Chena River Lakes Project  
Fairbanks, Alaska

*Overview of Tanana River monitoring and  
research studies near Fairbanks, Alaska*

OVERVIEW OF TANANA RIVER MONITORING AND  
RESEARCH STUDIES NEAR FAIRBANKS, ALASKA  
(with Appendices)

Prepared by  
U.S. Army Cold Regions Research and Engineering Laboratory  
Hanover, New Hampshire

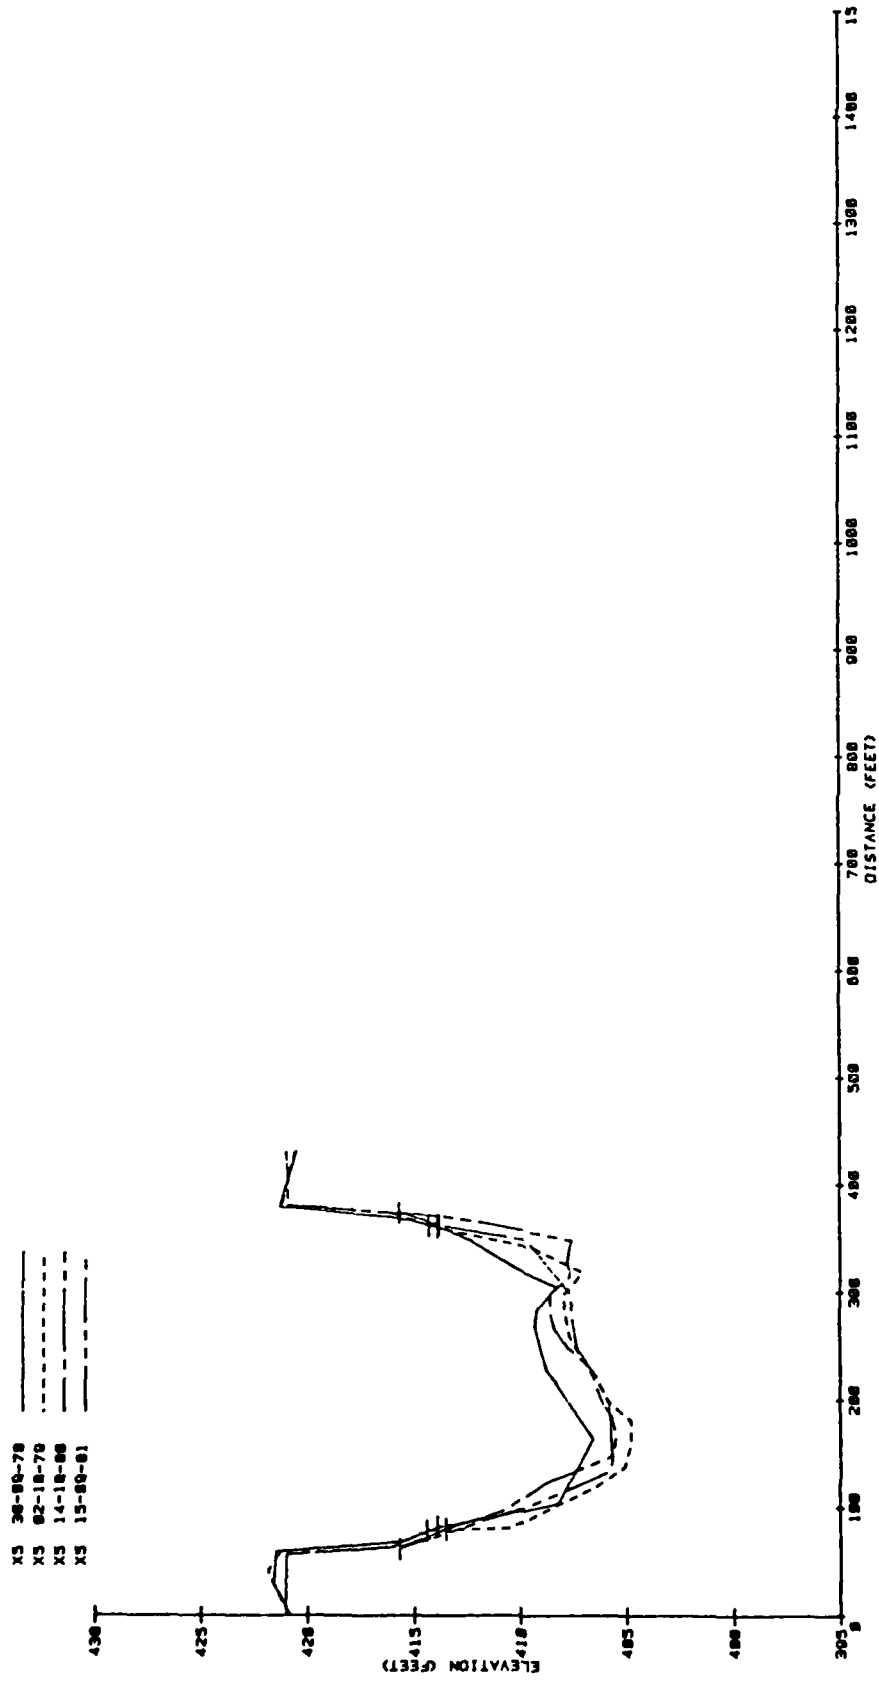
Figure 28. Chena River cross section X5, 1978-1981.

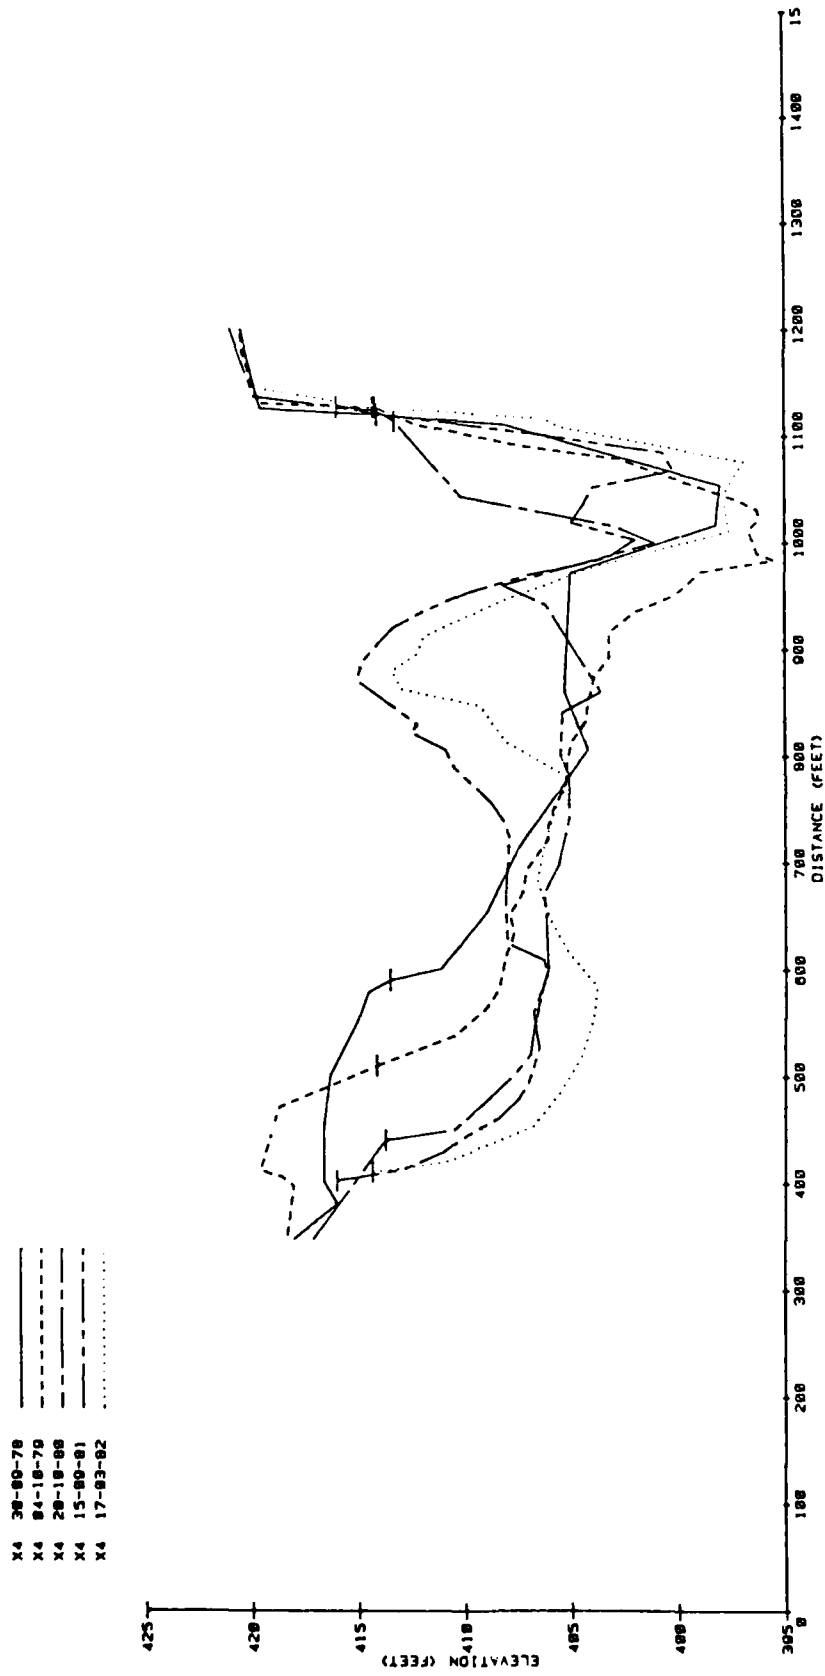
Figure 29. Tanana River cross section X4, 1978-1981.

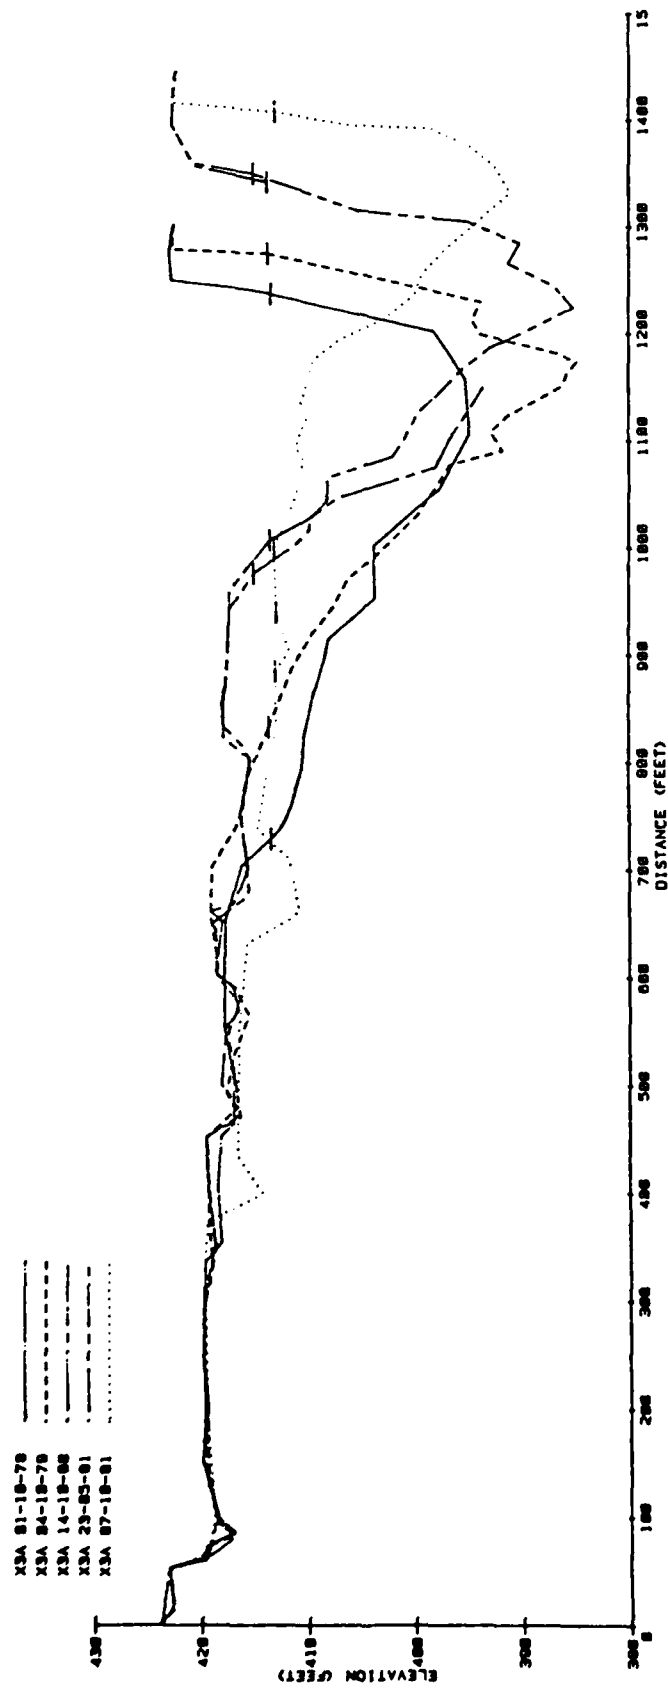
Figure 30. Tanana River cross section X3A, 1978-1981.

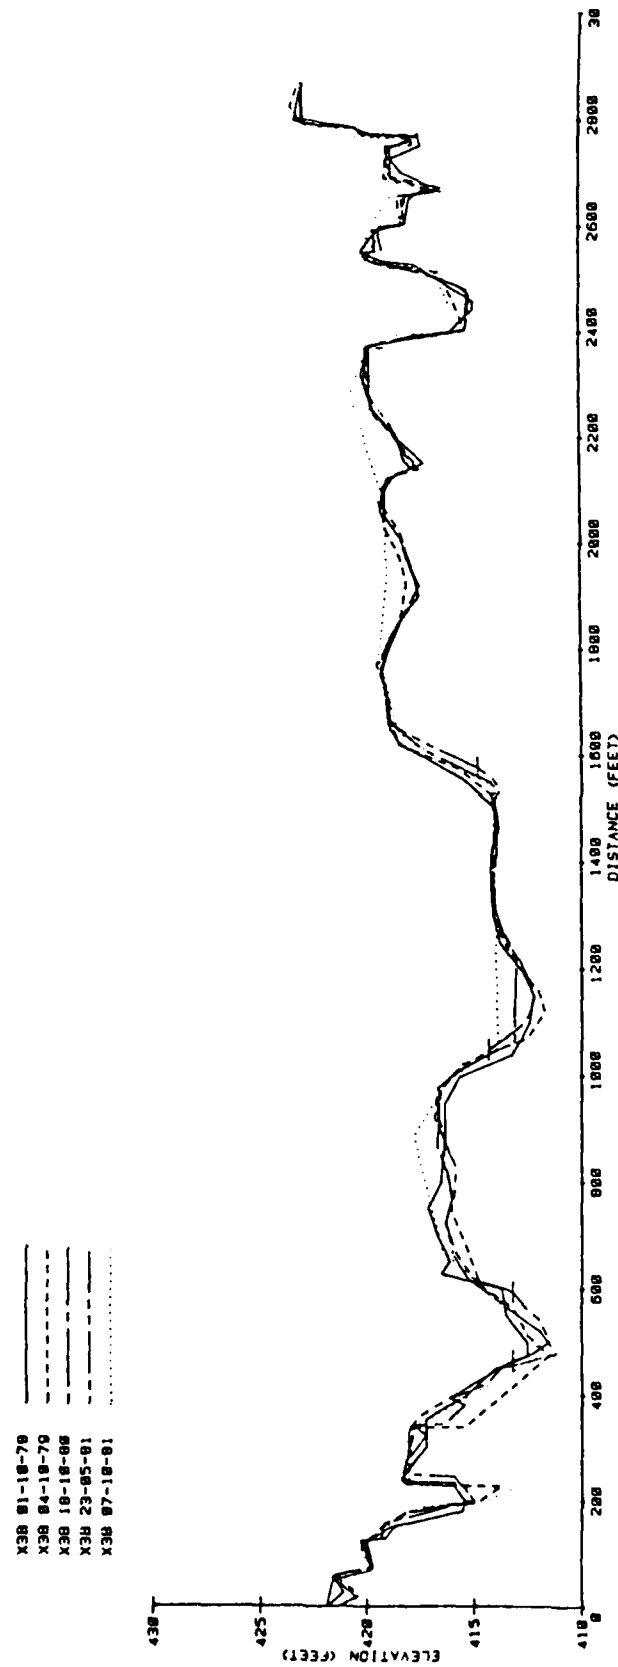
Figure 31. Tanana River cross section X3B, 1978-1981.

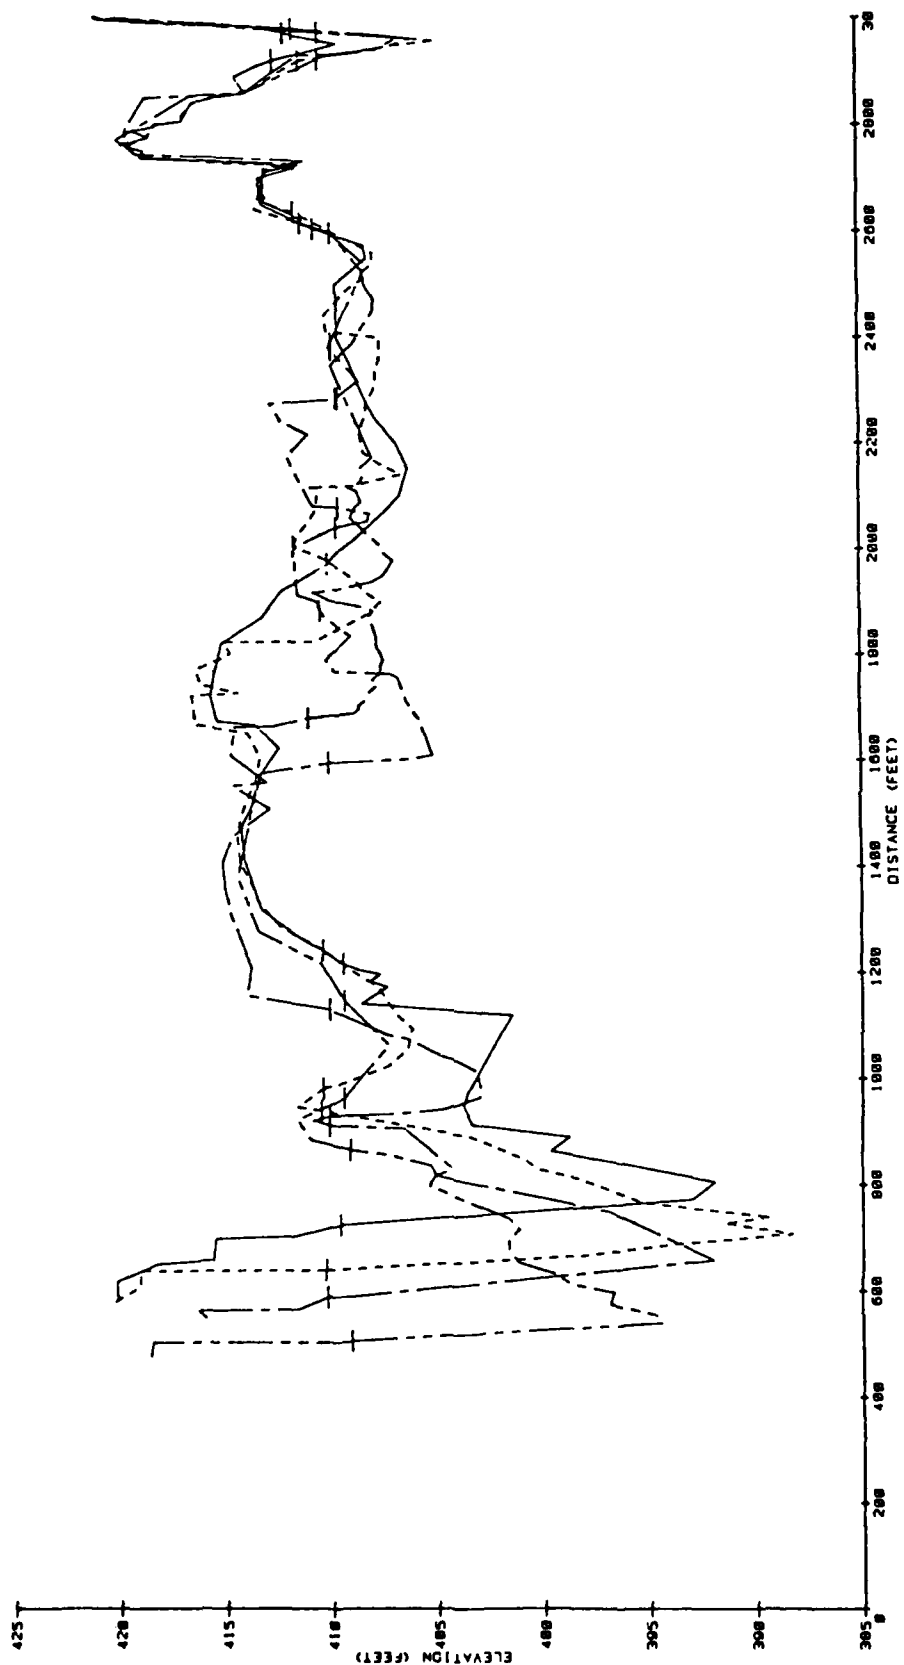
Figure 32. Tanana River cross section X2, 1978-1981.

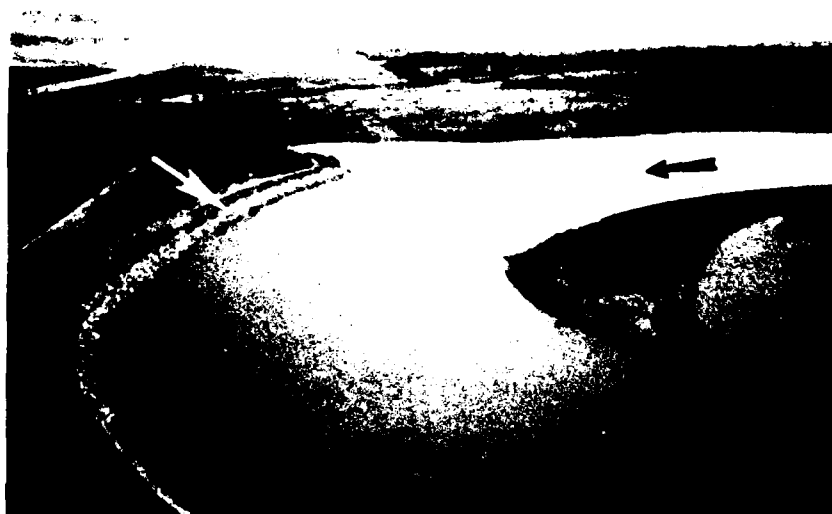
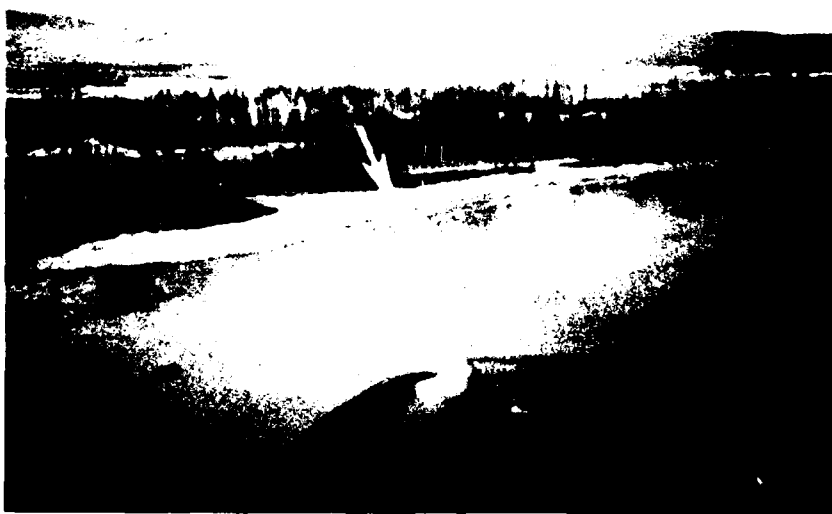
a. Upstream end of revetment.

b. Downstream end of revetment.

Figure 2. Upstream portion of reach 1 with riprap revetment (white arrow), 2 October 1980.

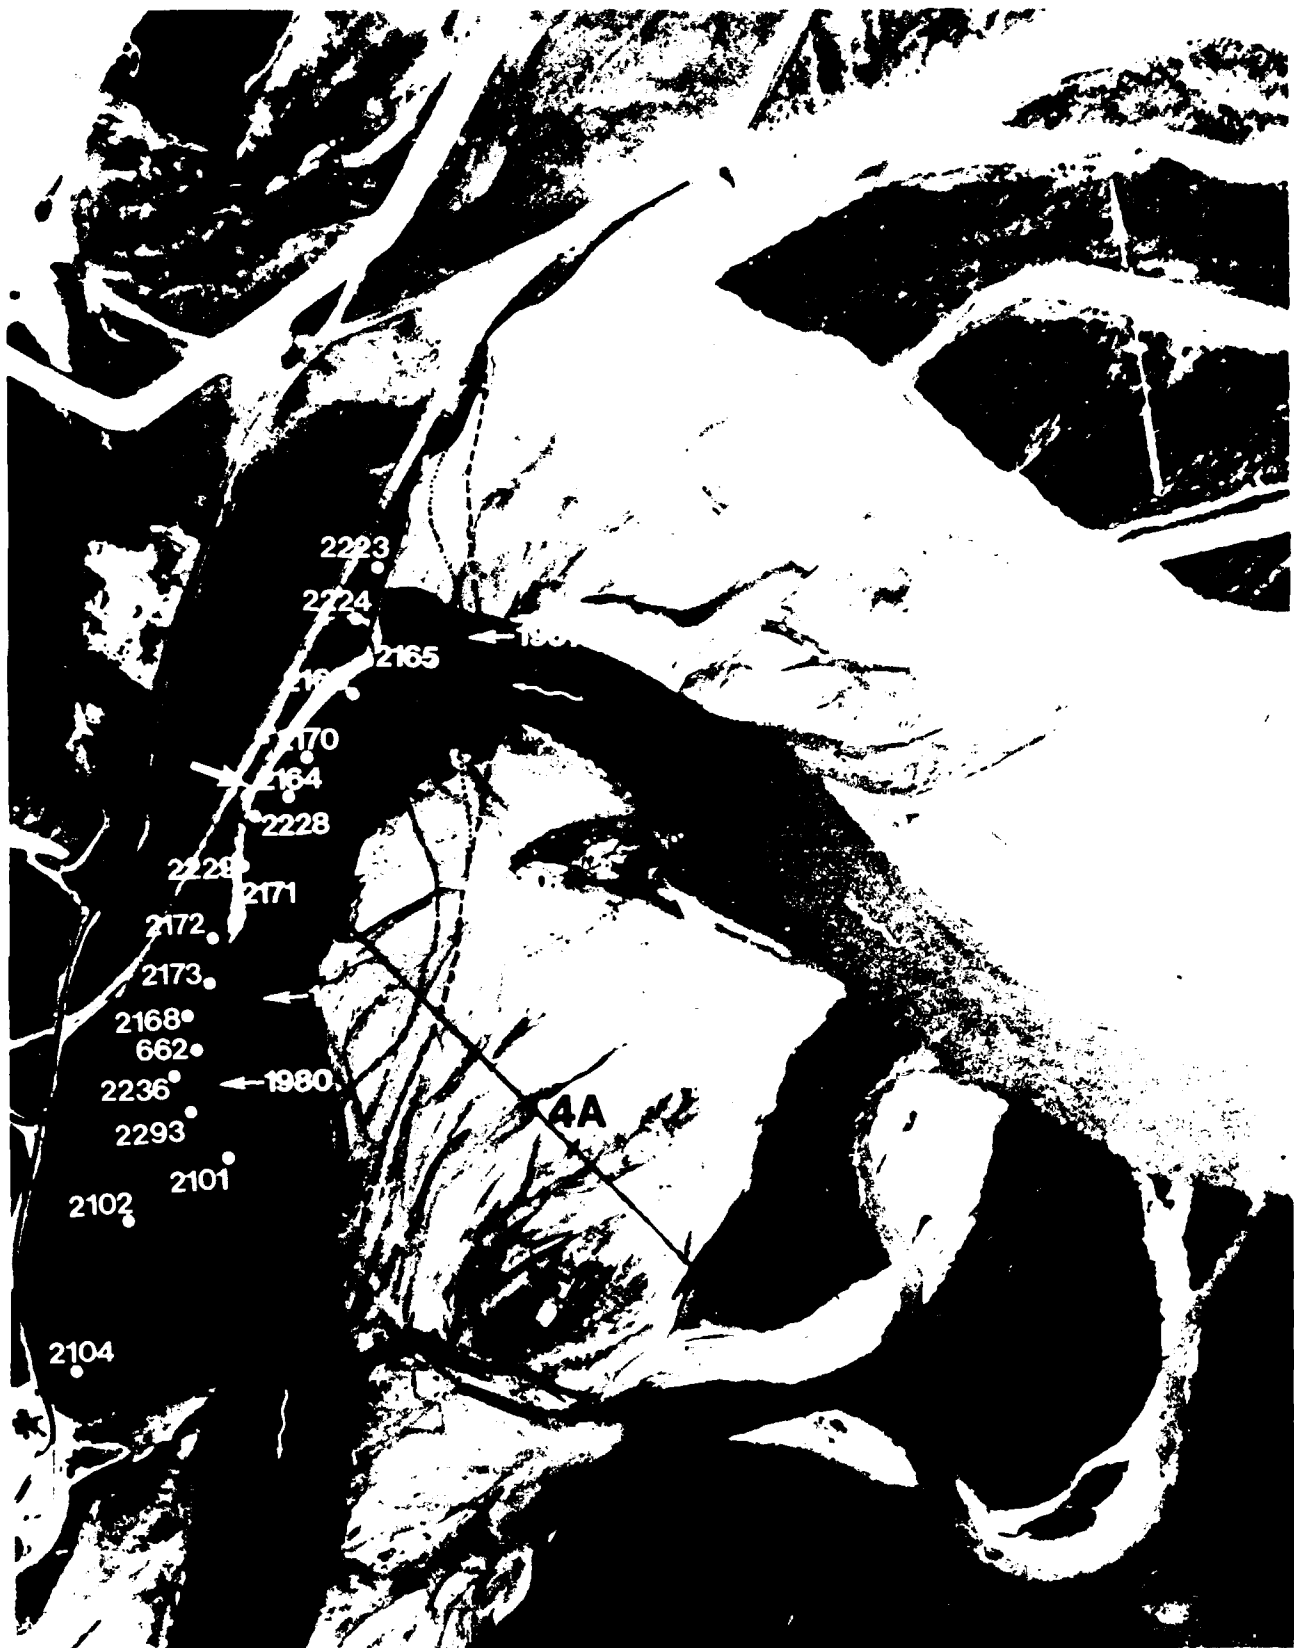
a. Reach 1, note revetment shown in Figure 2.

Figure 4. Approximate historical bankline positions (from Buska 1981) and well and river cross-section locations (photographs taken 7 May 1980; 1:5000 scale).

Figure 9. Soil series (from Rieger et al. 1963). The bankline is as shown in 1951 photography and is similar to that in 1948 (Fig. 4a). For purposes of this analysis, the two banklines were considered the same.

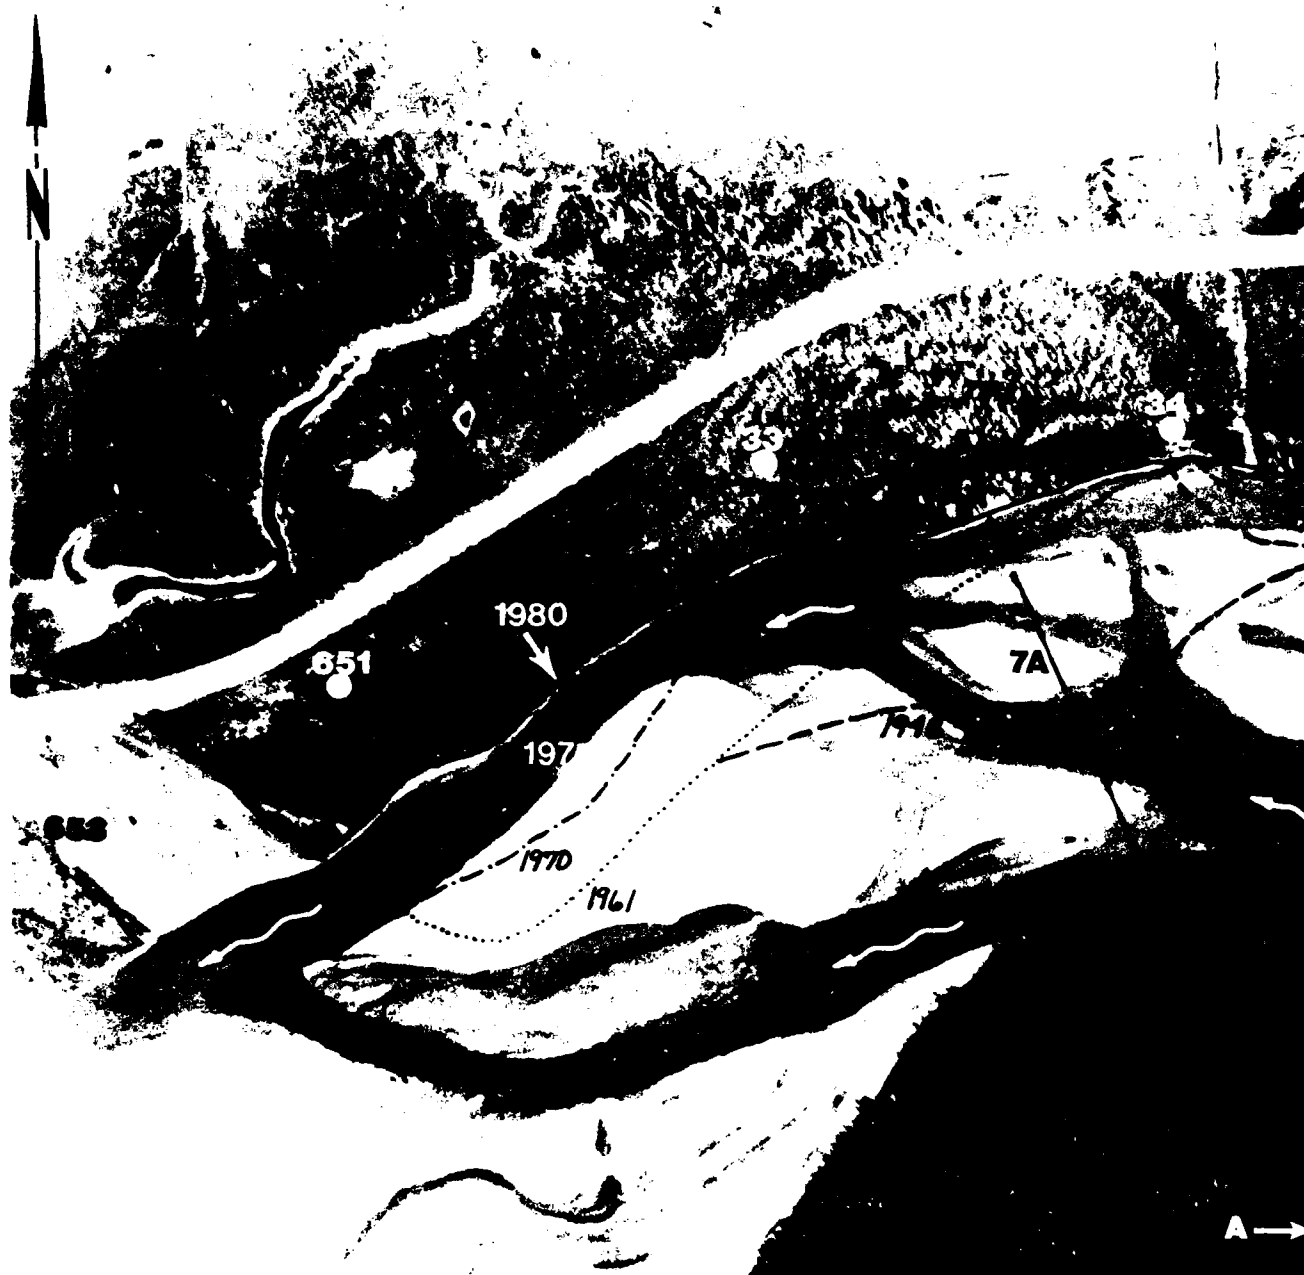
Figure 4 (cont'd).

b. Western part of reach 2.

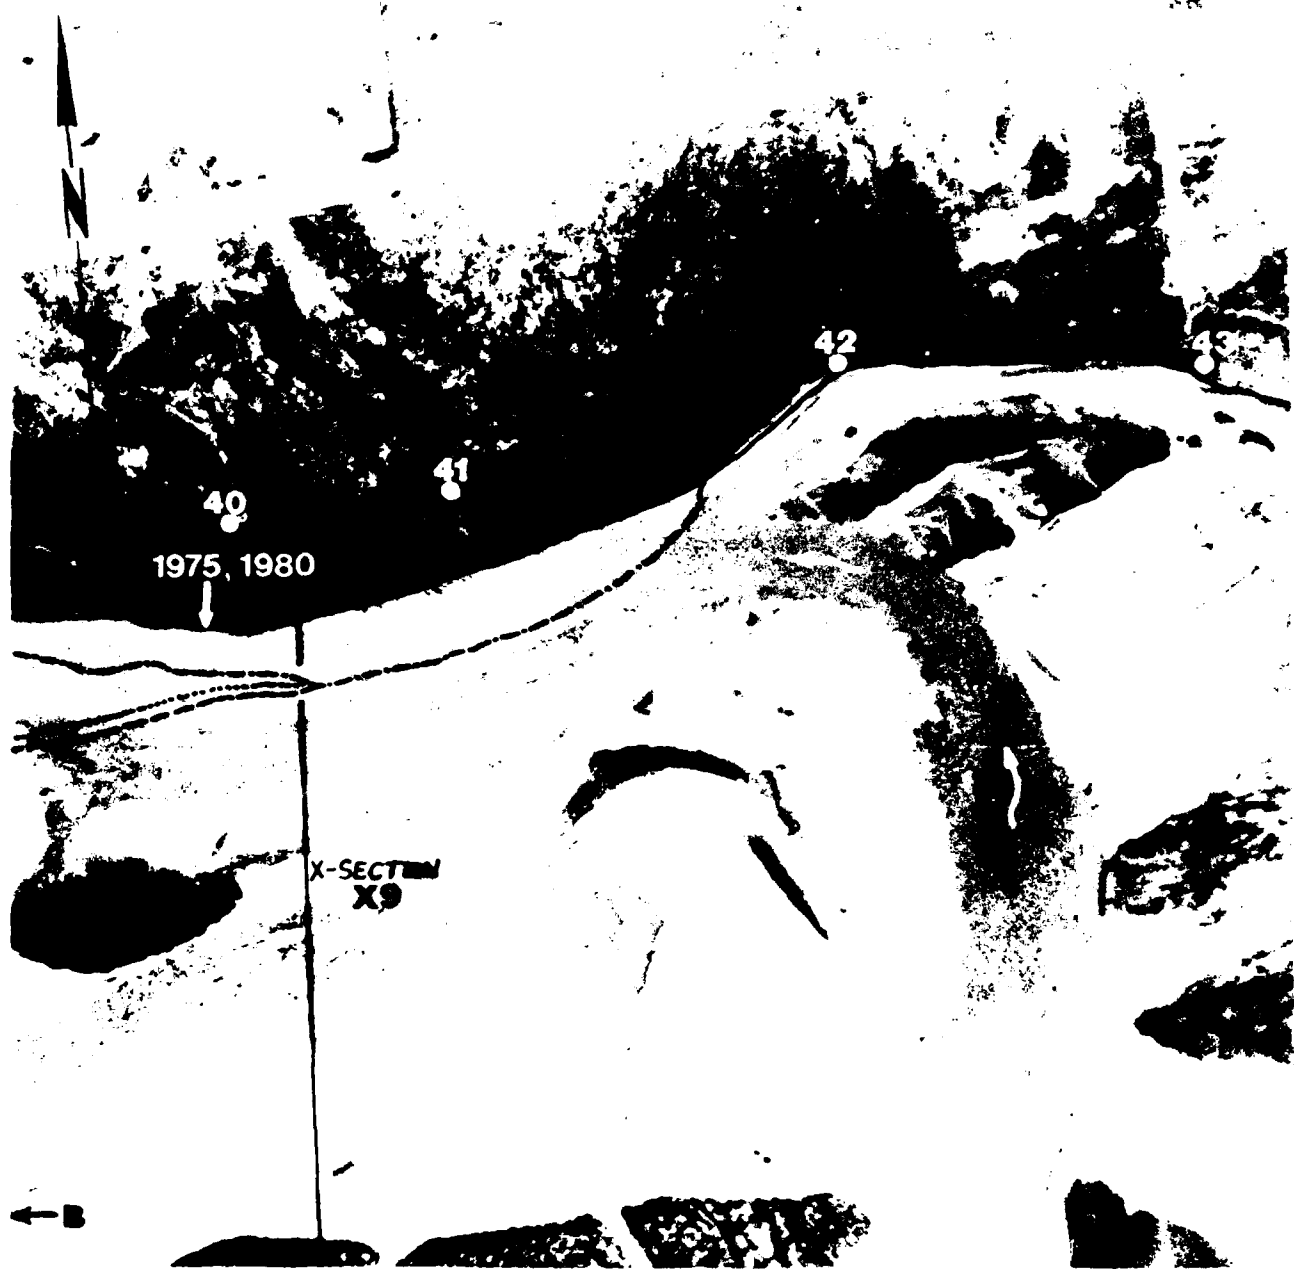
Figure 4 (cont'd).

c. Middle part of reach 2; note the USGS gauging station.

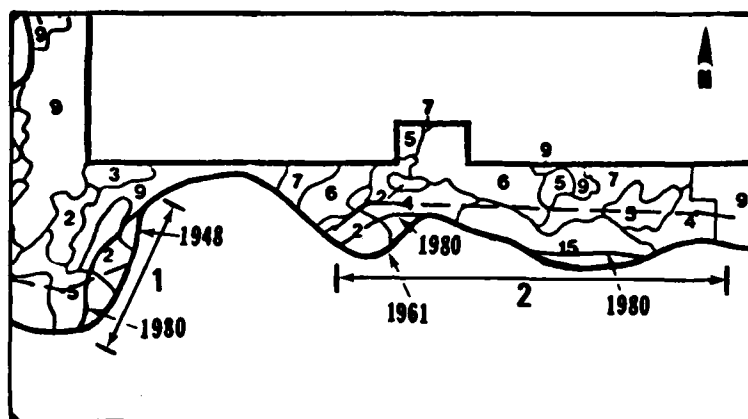
Figure 5. Vegetation distribution (Graham 1975); bankline position similar to that in 1948 along reach 1 (Fig. 4) and 1961 along reach 2 (Fig.4).

- 2        White spruce/paper birch
- 4        Balsam poplar/paper birch
- 5        Paper birch/black spruce (usually a wetland)
- 9        Water and cultural features
- 15       Balsam poplar/white spruce

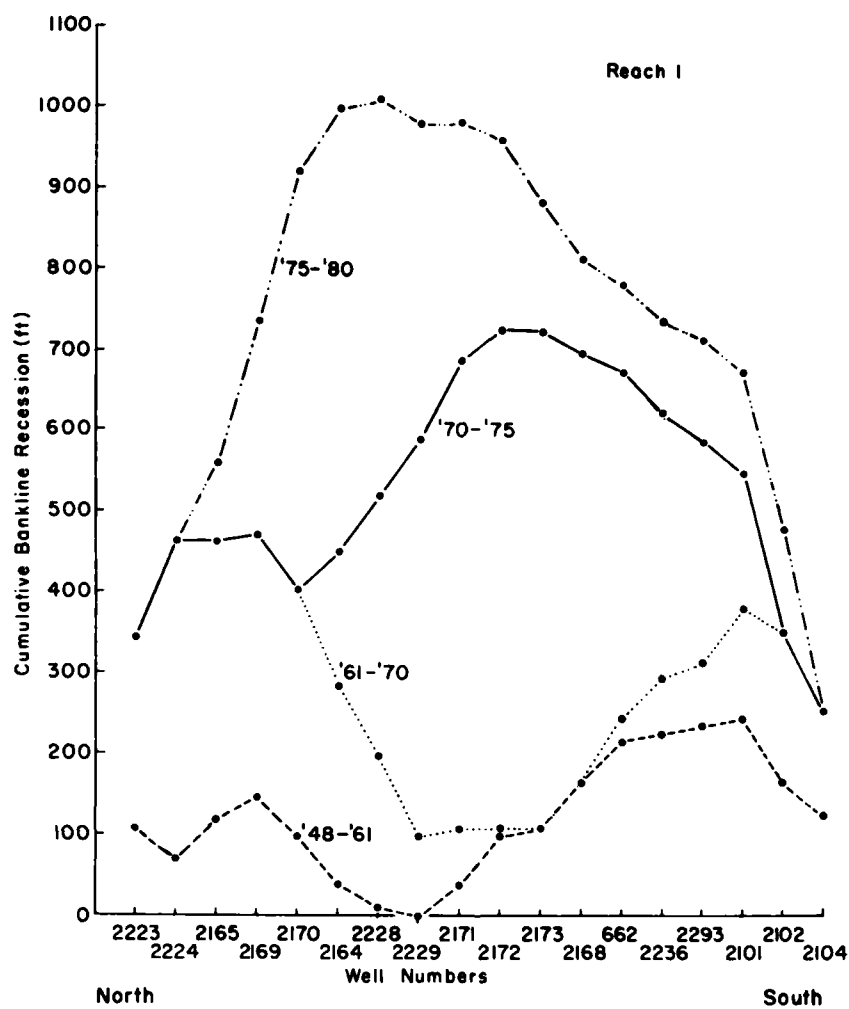
Figure 6. Bankline recession adjacent to the wells along reach 1.

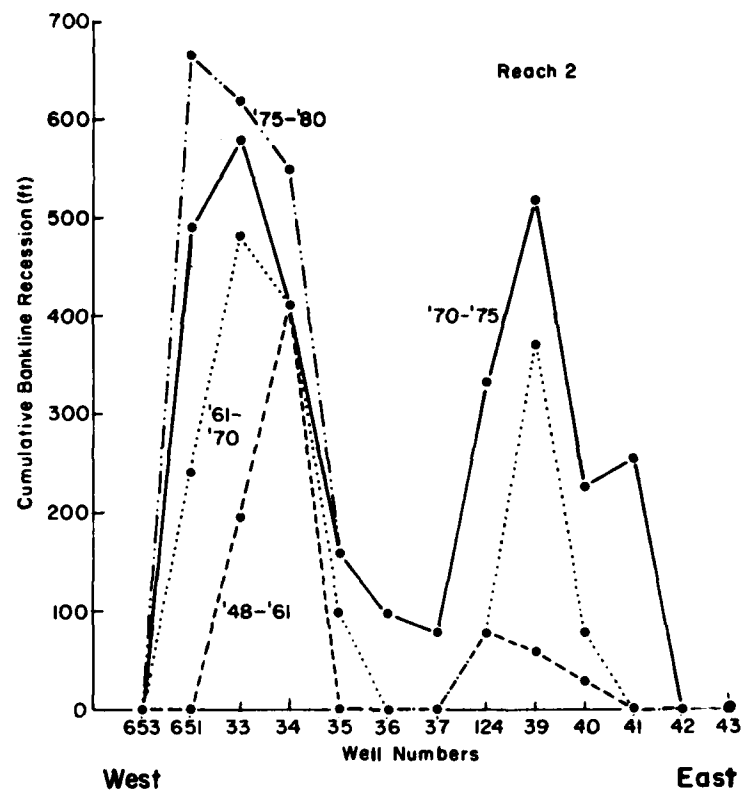
Figure 7. Bankline recession adjacent to the wells along reach 2.

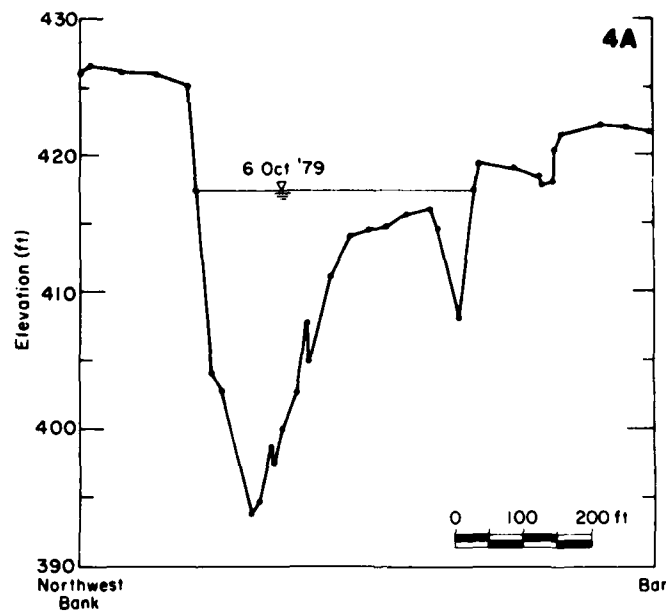
Figure 8a. West part of cross-section 4A (locations on Fig. 4).

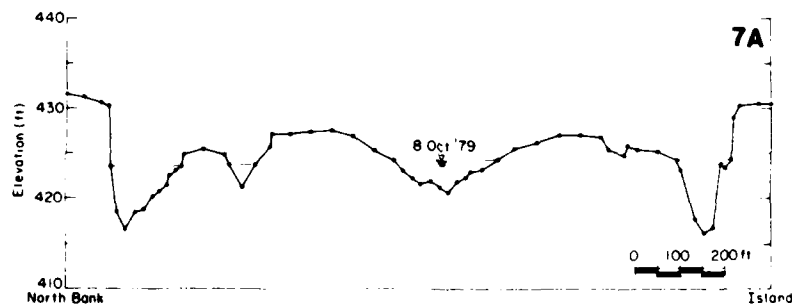
Figure 8b. Cross section 7A.

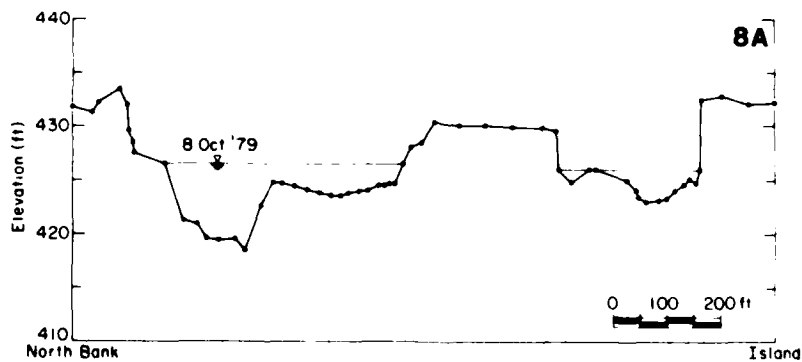
Figure 8c. Cross section 8A.

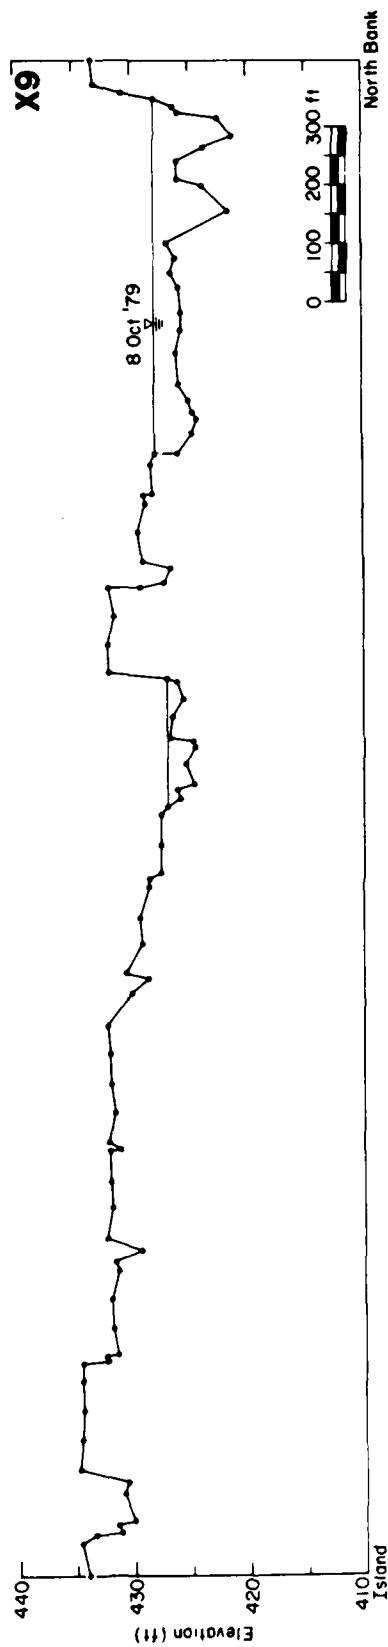
Figure 8 (cont'd)

Figure 8d. Cross section X9.

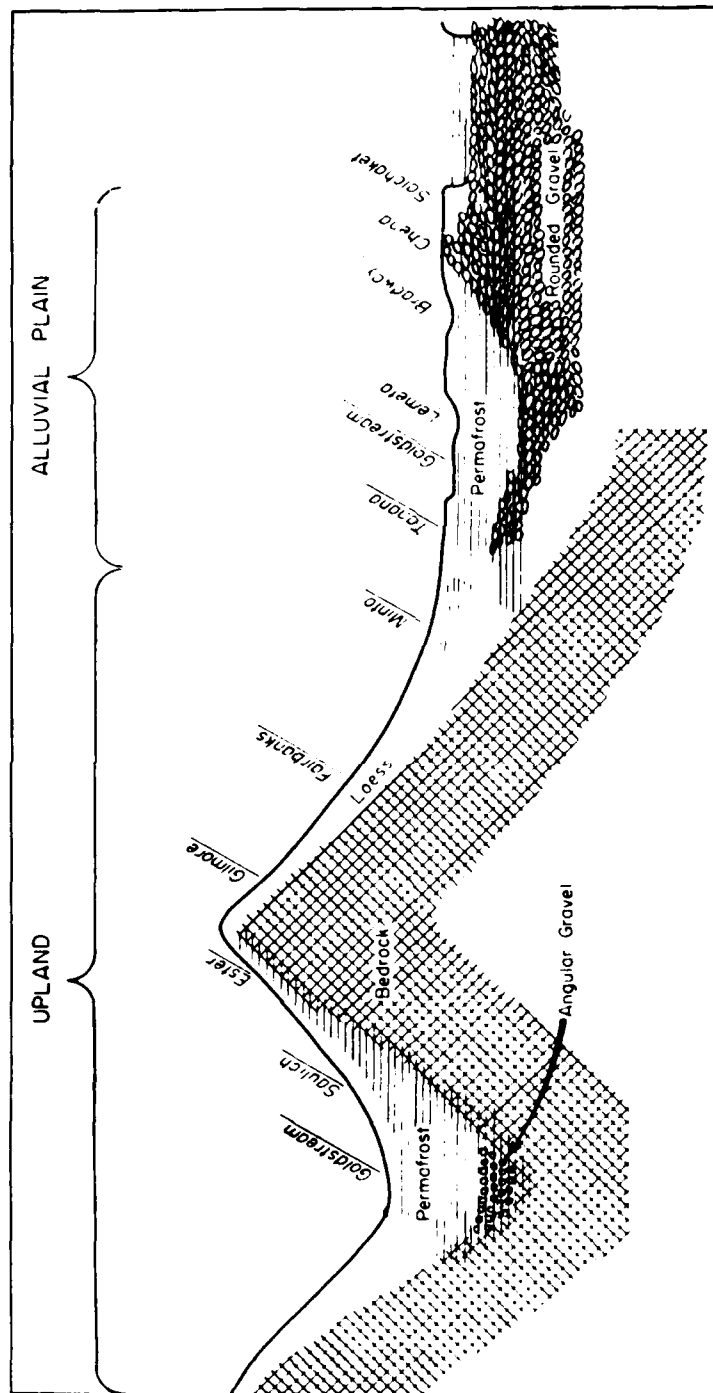
Figure 10. Generalized landscape showing relative distributions of soil series, underlying material and permafrost (from Rieger et al. 1963).

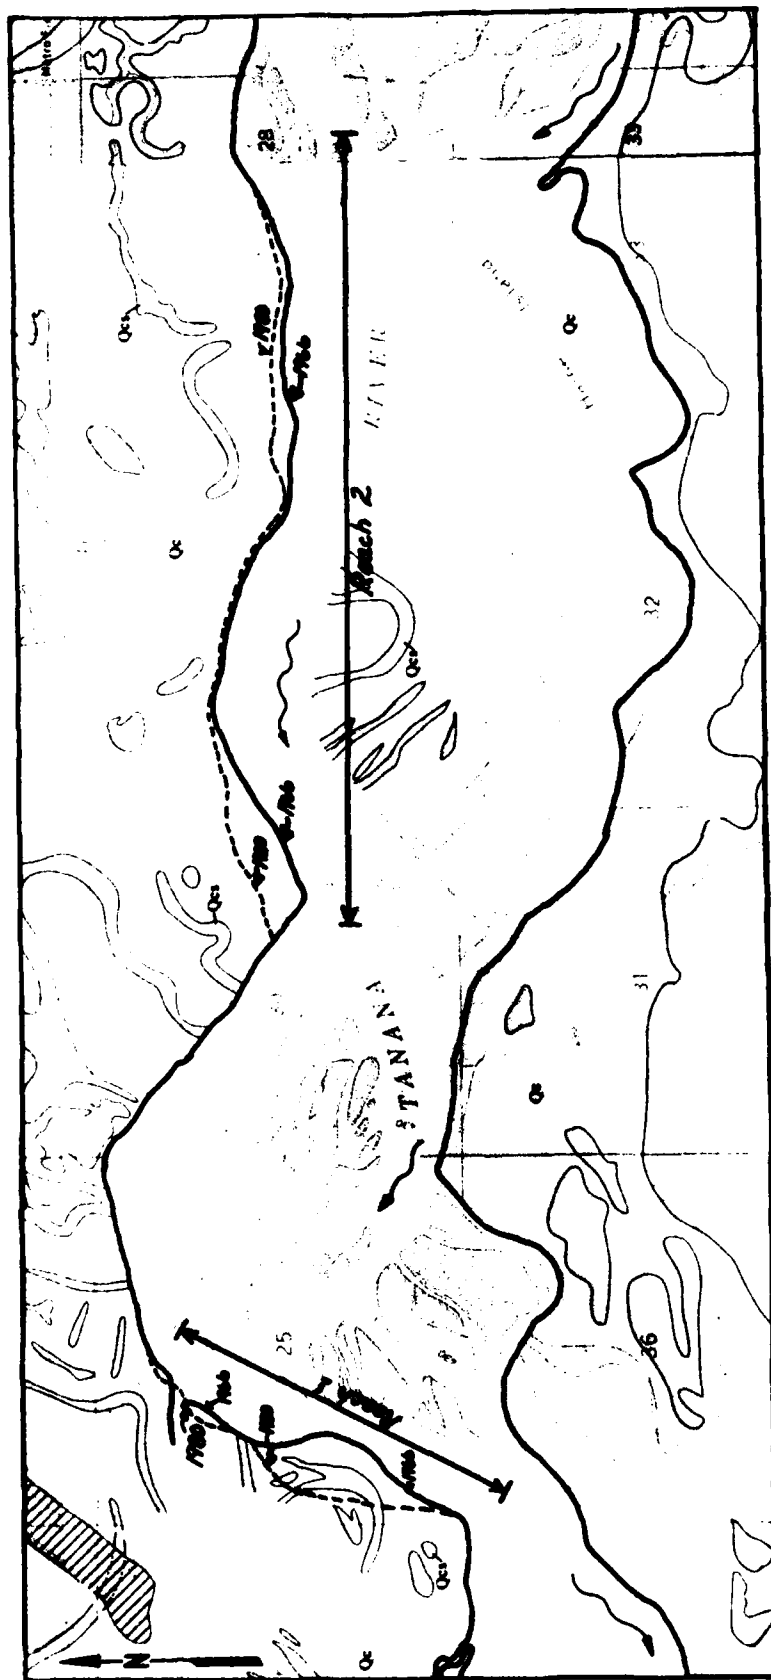
Figure 11. Distribution of the sands and gravels ( $Q_c$ ) and swale and slough deposits ( $Q_{cs}$ ) of the Chena alluvium (from Pévé et al. 1976). The bankline is as shown on 1966 photographs and is similar to that in 1970 (Fig. 4). For this analysis, the two banklines were considered the same.

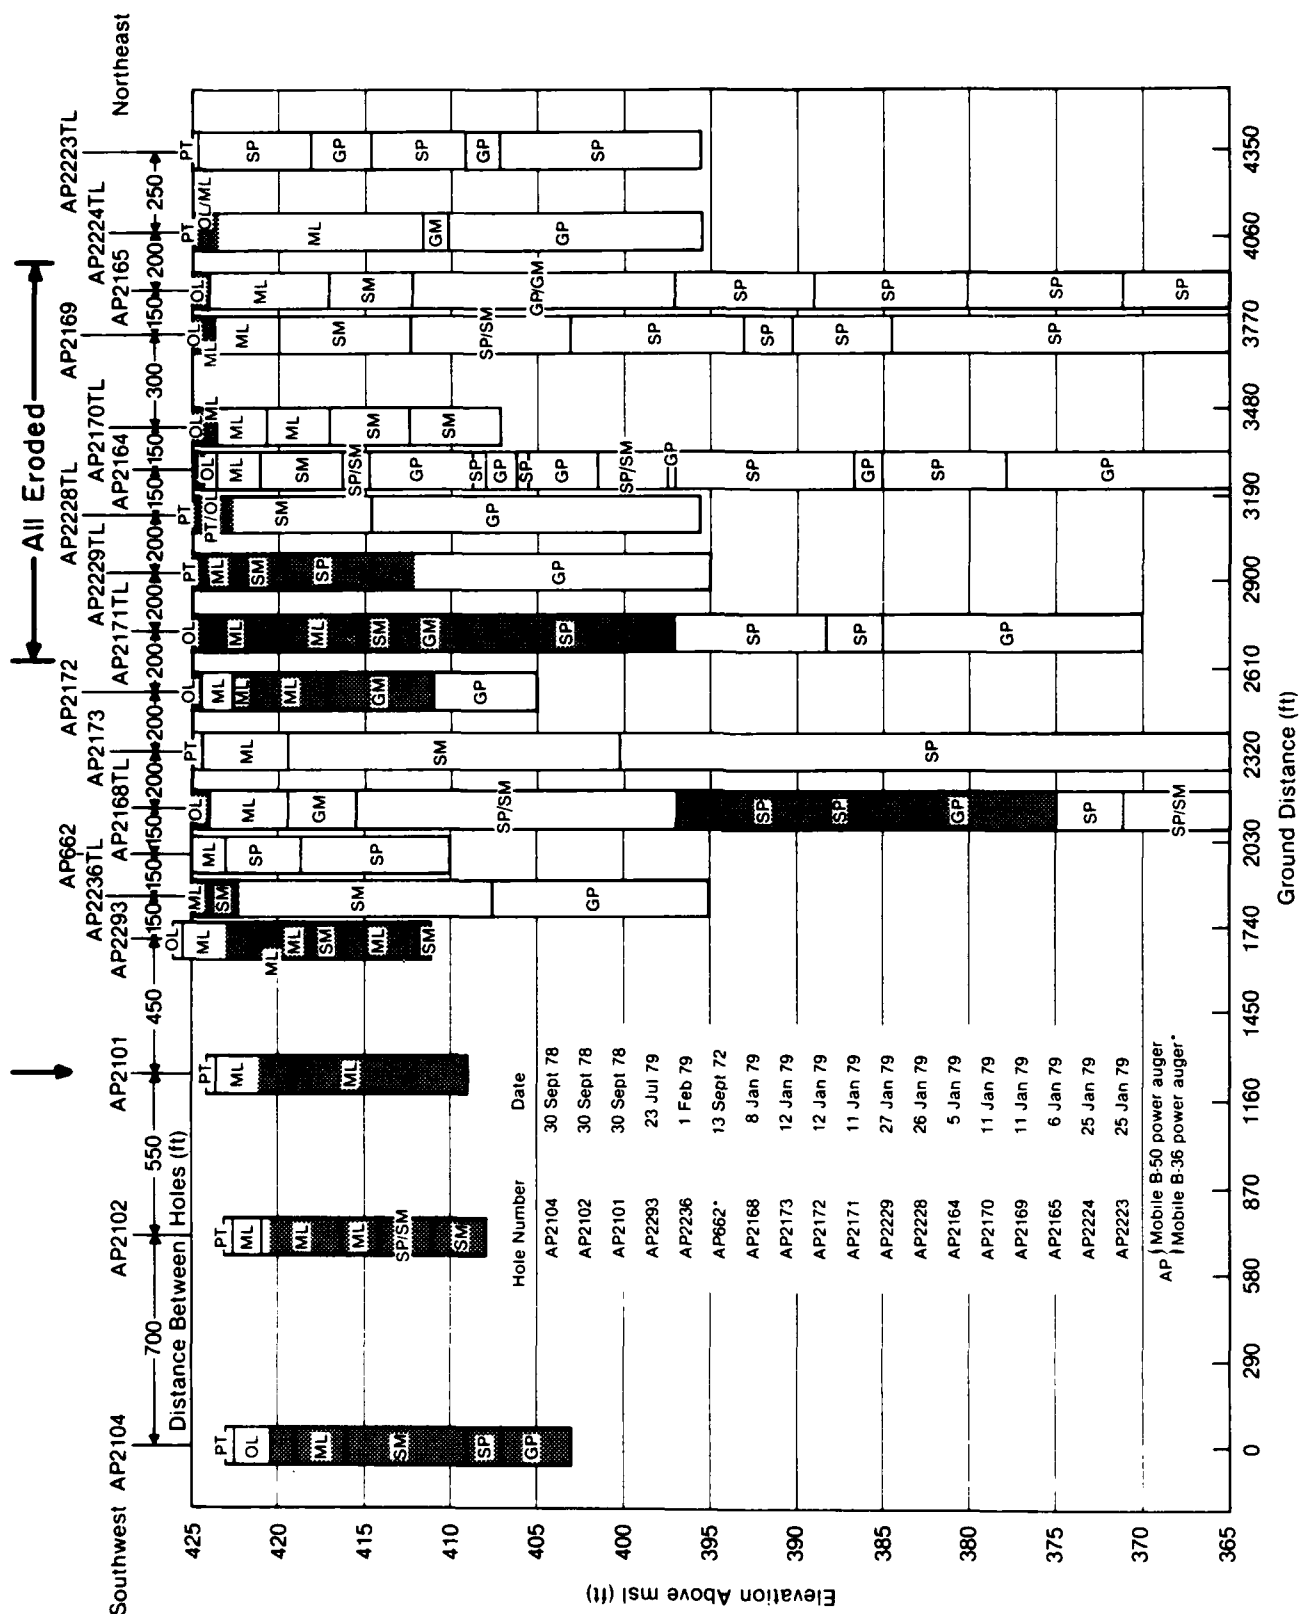
Figure 12. Well logs, reach 1; stiped areas were frozen when drilled.

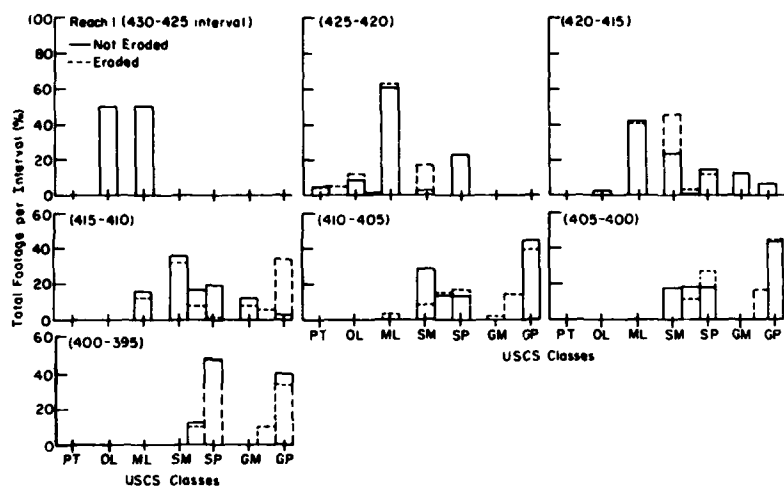
Figure 13. Sediments in eroded and uneroded wells, reach 1.

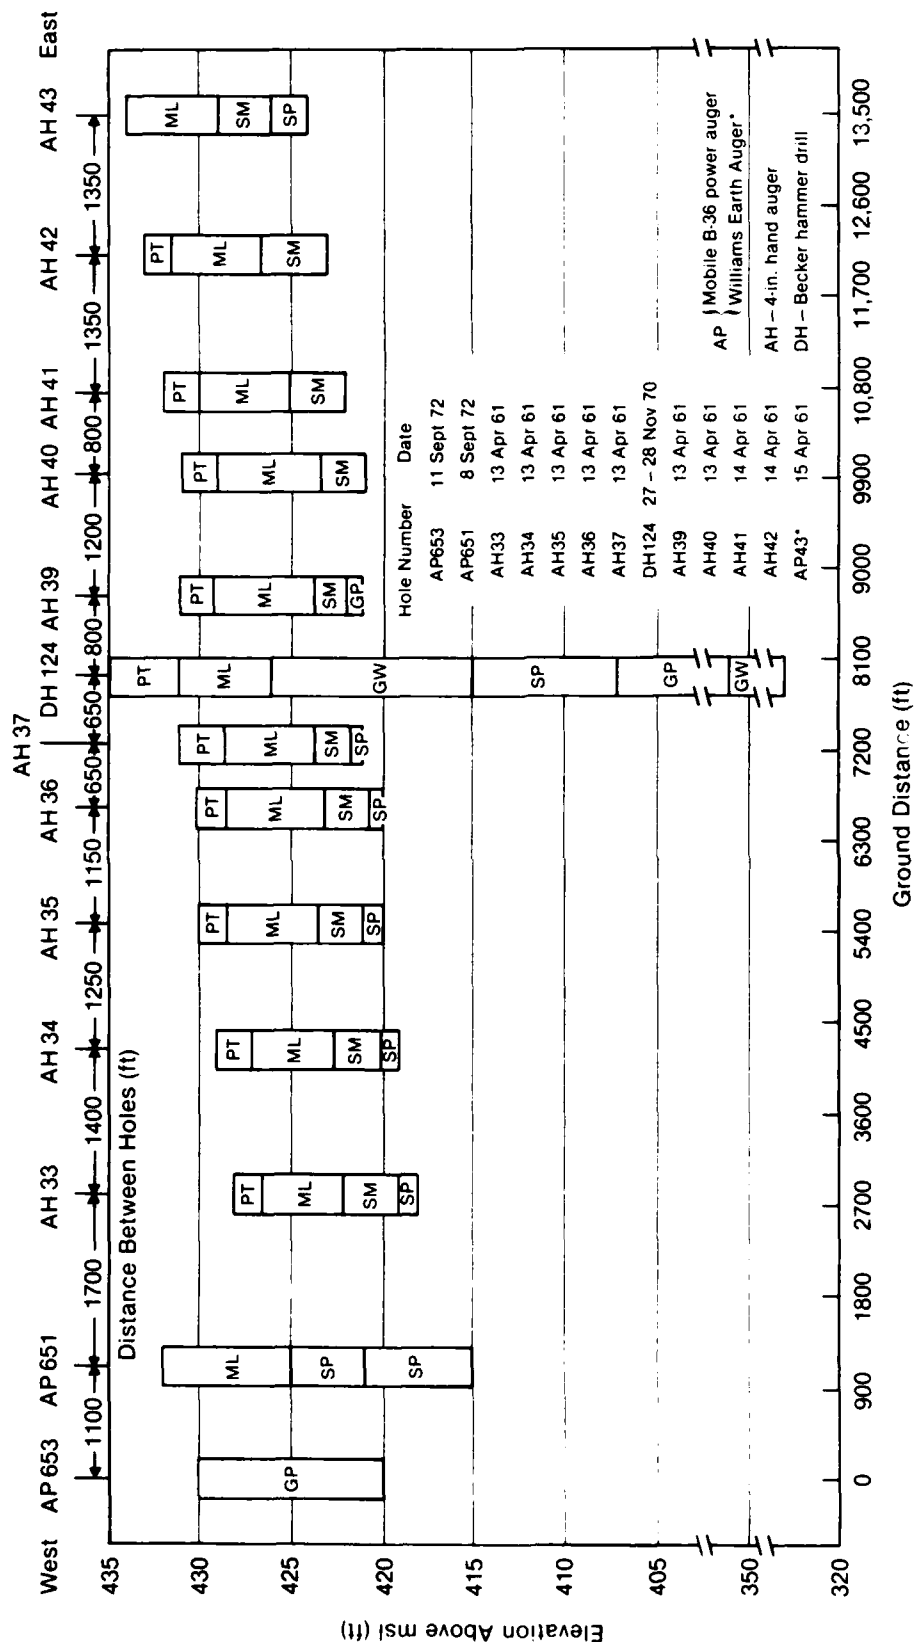
Figure 14. Well logs, reach 2.
